Electric field mapping inside metallized film capacitors

61st Reliability and Maintainability Symposium (RAMS), 26-29 Jan. 2015, Palm Harbor

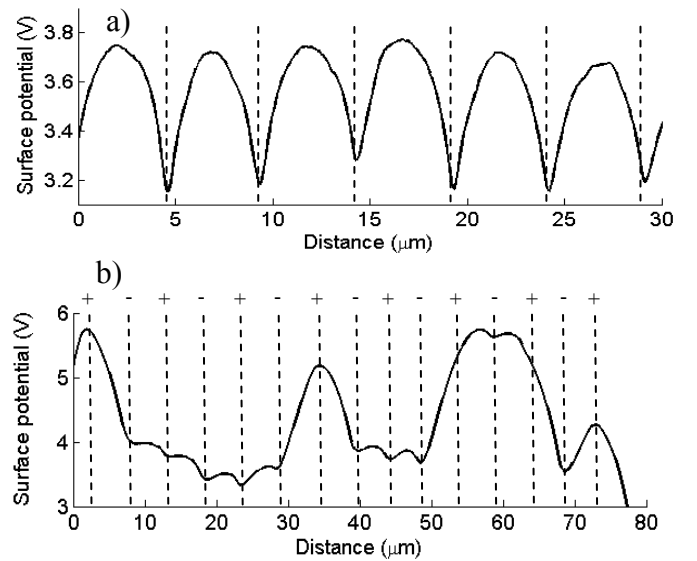
Figure 5: Cross-section profiles of the surface potential distributions measured closer to the edge of the capacitor a) on the grounded degraded capacitor and b) on the same capacitor with 5V applied across it. The dashed lines indicate the expected position of the metallization.

The measurement on the grounded capacitor in figure 5a shows a similar pattern as the one shown in figure 4a. The only difference is that the surface potential variations are smaller. The measurement on the biased capacitor (shown in figure 5b), however, is significantly different from the one shown in figure 4b. It appears that only four out of eight metallization layers preserve contact to the end-spray with the 5V applied. Moreover, at least the metallization layer at $60\text{ }\mu\text{m}$ is not connected to the grounded end-spray as it was supposed to. It could, however, also be caused by missing metallization

layers at 55 μm and 65 μm if compared to figure 4b. At this point it can not be concluded if the rest of the metallization layers are still connected to the ground. It is, however, observed that the surface potential variations at 10-30 μm and 40-50 μm are quite small (around 0.2V), which also could indicate poor connection or lack of connection to the end spray.

Based on the results presented in figures 4 and 5 two conclusions on the failure analysis can be drawn. The metallization layers were corroded and some had lost contact to the end-spray as a result of the accelerated testing. The corrosion level was independent of measurement position on the capacitor, whereas the number of metallization layers without contact to the end-spray increased in the outer layers compared to the layers near the center of the capacitor.
